**Flood Control Project Maintenance  
Levee Inspections**

**Fall 2018 Levee Maintenance Deficiency Summary Report**

**Levee District No. 0009 (Sutter County)**

Waterway	Bank	Unit Miles	Inspection Start/End	Inspector
Unit No. 01 Sutter County, Feather River	Right	6.25	10/18/2018 10/18/2018	Sterling York

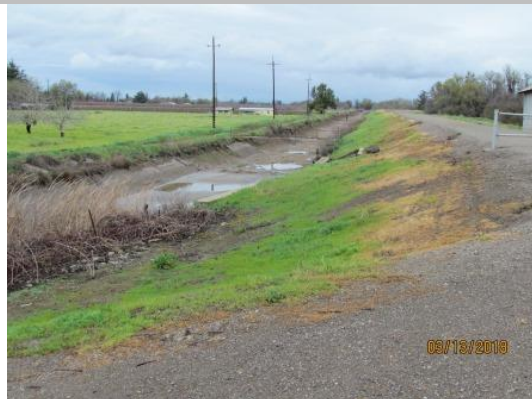
Photo 1 of 1 : FA\_2018\_LD0009\_202\_20\_20180918\_00004.jpg

LM Start	5.66	Rating **	M	Issue No.	20
LM End	6.00	Issue Type +	En	Location *	LS
Category	Earthen Levee			GPS Latitude/Longitude	
				Start	End
Item	Encroachments			39.247349 °	39.252258 °
				-121.637341 °	-121.637077 °
DWR ID	DWR_LD0009_01_f_2016_20				
Comment Code					
DT : Ditch					
Inspector Comment					
Ditch at the toe of the landside levee.

View looking upstream of ditch at the toe of the landside levee.
